# ENGINEERED INTERLOCKING CONCRETE PAVEMENT

*Hong Kong International Airport*

## Building for the Future

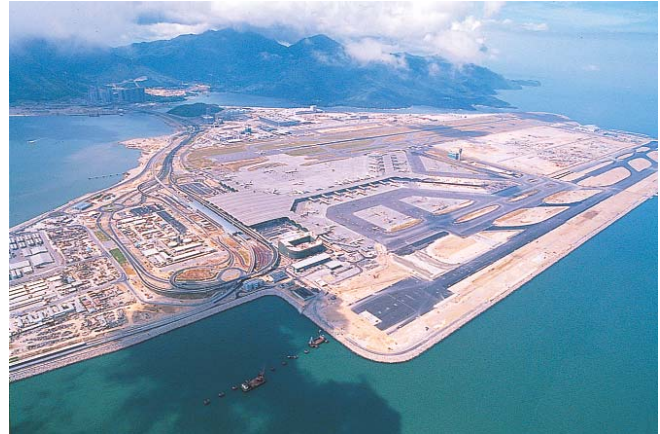
Figure 1. Hong Kong International Airport rests on native land and fill from two islands and soil dredged from the sea.

Parts of two islands were excavated and used to reclaim land from the ocean while the remainder of the airport-island came from marine borrow areas in Hong Kong territorial waters. The combination of marine dredging and casting island mountains into the sea created 4.8 square miles (1,255 ha) of land for the airport. Figure 1 shows an aerial view of the massive construction project. The island supports:

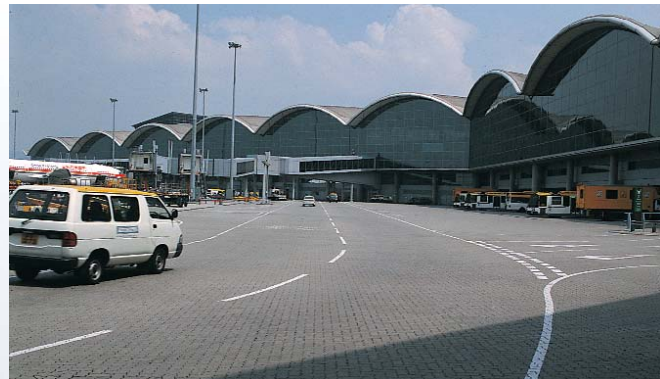
Figure 2. Interlocking concrete pavements were selected because they would tolerate expected settlement around the terminal building and remain serviceable.

Interlocking concrete pavement was selected because rigid PCC pavement could not tolerate expected subgrade settlement without severe distresses that could interrupt airport operations. A flexible pavement surfaced with interlocking concrete pavers was the logical solution for aircraft parking areas subject to differential settlement such as around the terminal cut-and-fill areas over service tunnels. See Figure 2.

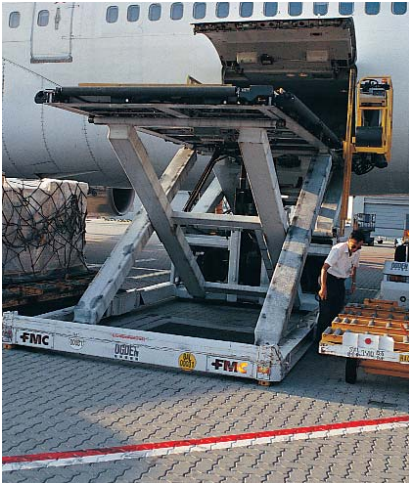
Figure 3. Steel stabilizer legs under cargo loading equipment concentrate point loads on pavements.

interfere with aircraft operations, the pavers can be removed, the areas re-profiled to acceptable elevations, and the same pavers reinstated. Unlike asphalt, concrete pavers resist degradation from fuel, oils, and indentation from wheel loads exceeding 50,000 lbs (22,680 kg). Likewise, pavers resist indentation from stabilizer legs used to position cargo handling equipment next to aircraft. Figure 3 shows cargo loading equipment.

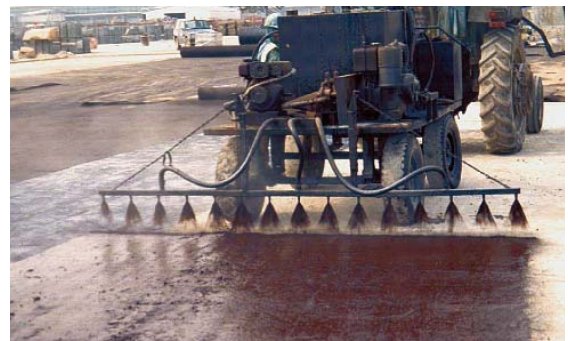
Figure 6. A bitumen tack coat secures geotextile in place over the CTB. A thin layer of sand was then spread to keep the bituminous material from sticking to boots and tires.

approach prevented the CTB from cracking into large segments. The bitumen-impregnated geotextile formed a flexible impermeable barrier that prevented surface water and bedding sand penetrating into any cracks. Figure 6 shows the bituminous tack coat being applied to the geotextile placed over the CTB.

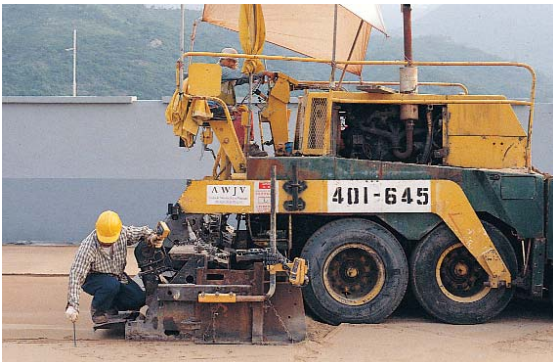
Figure 7. A sonic-controlled asphalt machine accurately placed,  $\frac{3}{4}$  in. (20 mm) thick bedding sand layer over a smooth CTB surface.

Experience has shown that insufficient hardness, poor gradation, or excessive thickness of the bedding sand under concrete pavers can cause distresses. These can include variable thickness and density, saturation and degradation from concentrated loads, uneven compaction or loss into cracks and joints. Errors in similar projects were avoided at Hong Kong airport because the specifications required a uniform,  $\frac{3}{4}$  in. (20 mm) sand layer made from clean, strong, well-graded material. A smooth CTB surface enabled use of this thin layer. Bedding sand was spread and screeded with a sonic-controlled asphalt spreader to a consistent  $\frac{3}{4}$  in. (20 mm) thickness. Figure 7 shows the asphalt machine spreading the sand and Figure 8 shows a close-up of the screeded bedding layer.

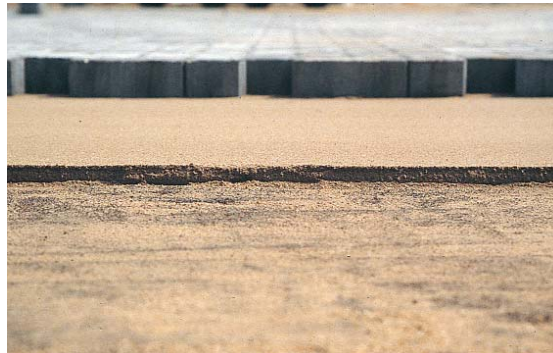
Figure 8. The screeded bedding sand maintained a consistent thickness since the surface of the CTB met tolerances for smoothness.

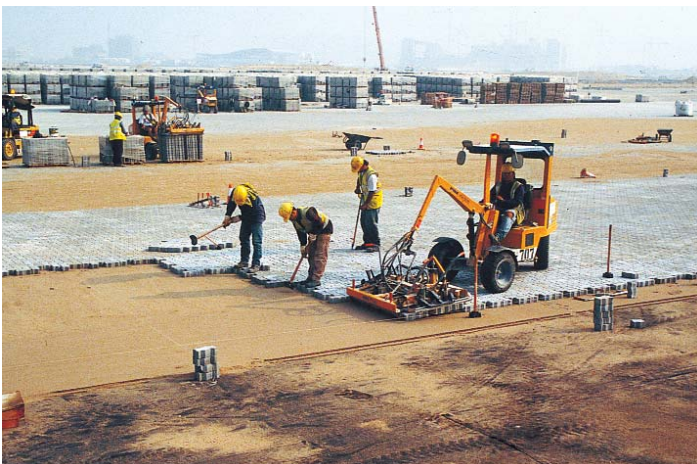
Figure 10. Mechanized installation accelerated paving by using three machines to place layers of pavers in their final herringbone laying pattern. Note the bundles of pavers in the background and the crew adjusting joint lines and tightening each layer against its neighbors.

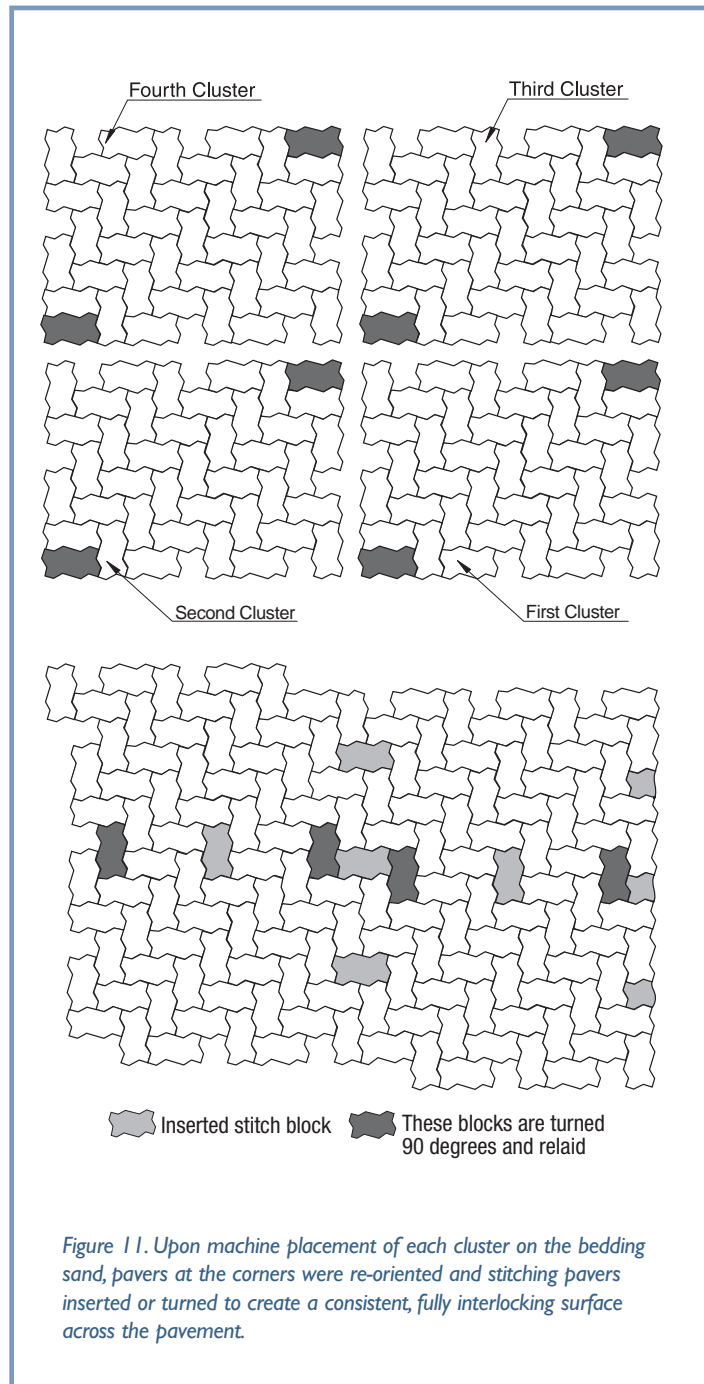
Figure 11. Upon machine placement of each cluster on the bedding sand, pavers at the corners were re-oriented and stitching pavers inserted or turned to create a consistent, fully interlocking surface across the pavement.

For the Hong Kong project, each layer included four pavers at the corners re-oriented during installation to create a completely interlocking concrete pavement among neighboring layers. Stitching units also tied each layer to its neighbors. Figure 11 illustrates the movement of corner pavers and location of stitching pavers that join a layer to its neighbors.

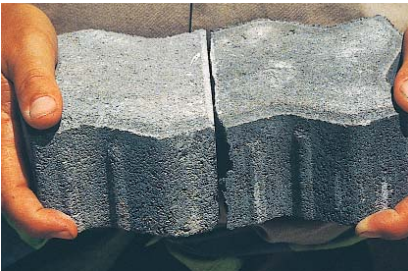
Figure 14. The left half shows a saw-cut paver with a chamfer on the cut edge. The right half shows a paver with rough edges cut with a manual splitter. No pavers at Hong Kong were cut with a splitter. Saw-cut pavers and chamfers eliminate risk of ingestion of chipped concrete into jet engines.

to replicate the top edges on whole pavers. See Figure 14.

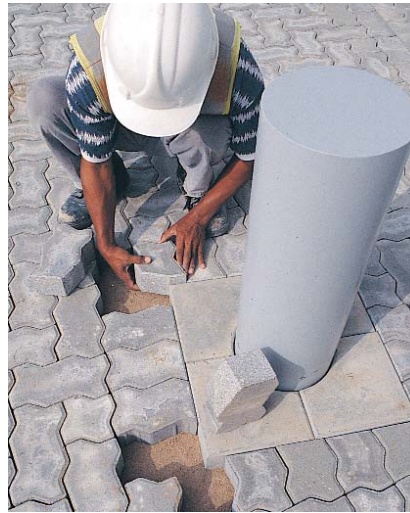
Figure 13. Cut pavers were fitted around concrete collars at bollards and at utility structures.

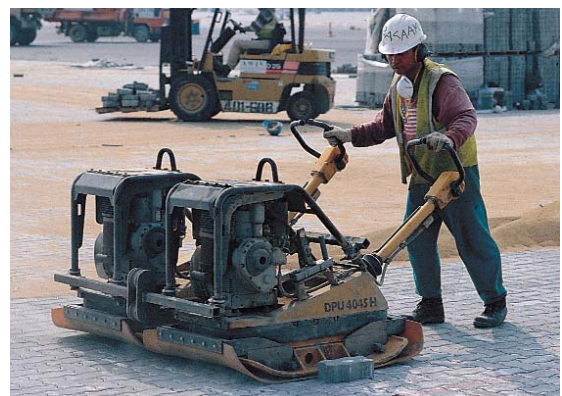
Figure 15. 9,000 lbf (40 kN) plate compactors were used to compact the pavers into the bedding sand, then again to compact the joint sand into the joints. Two were joined for greater efficiency.

The pavers were seated into the bedding sand using dual 990 lb (450 kg) plate compactors on a rubber pad that transmitted a centrifugal compaction force of 9,000 lbf (40kN) or 11.6 psi (0.08 MPa). The large machine size and plate area enabled faster and more consistent compaction. Any cracked or damaged units were immediately removed and replaced. After an area was paved and compacted, it was immediately checked and the joint sanding proceeded if the installed pavers were in full compliance with the specifications. The joint sand was swept and vibrated into the joints until full with the same compactors. See Figure 15.

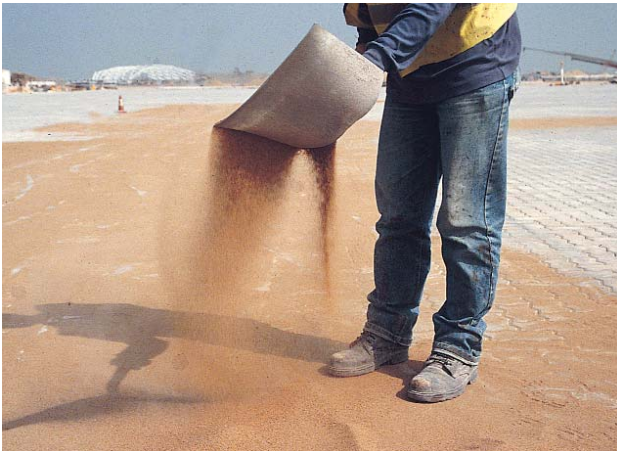
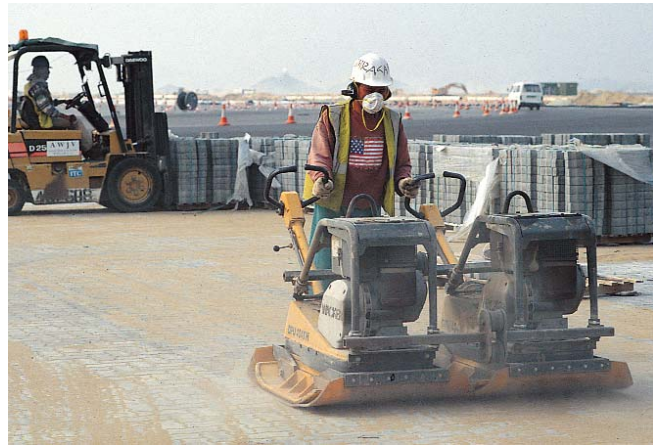
Figures 16 and 17. Dry joint was distributed across the compacted pavers and compacted into the joints until full. The joint sand gradation was finer than the bedding sand.

Like the bedding sand, no suitable joint sand was available locally so it was necessary for AWJV to develop a drying, screening and bagging facility to process dredged joint sand on the site. Figure 16 shows the joint sand which had a finer gradation than the bedding sand. Figure 17 shows compaction of sand into the joints.

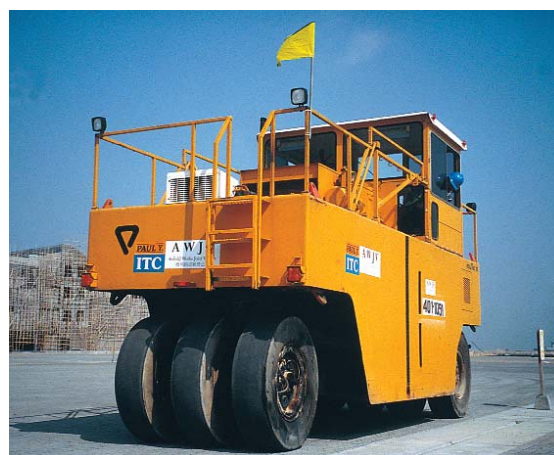
Figure 18. This 44-ton (40 T) machine rolled the completed surface of the pavers (prior to application of the sealer) to prove that they were seated and that the joints were full of sand.

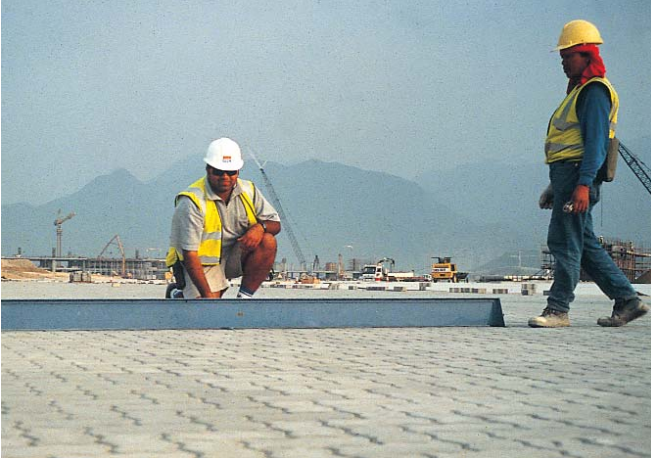
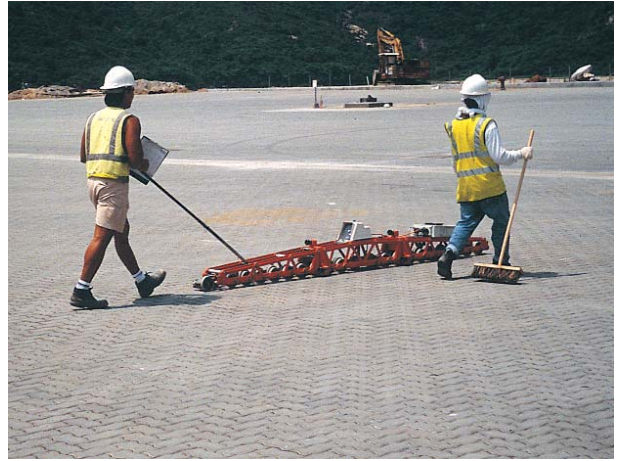
Figures 19 and 20. Checking surface tolerances with a straightedge and overall smoothness ensured a pavement amenable to keeping aircraft level during refueling.
