# Using Field Tests to Evaluate the Hydraulic Performance of Existing Concrete Block Permeable Pavements

November 2020

by Tom Emerton BSc (Hons) GMICE<sup>1</sup> and Chris Griffiths<sup>2</sup>

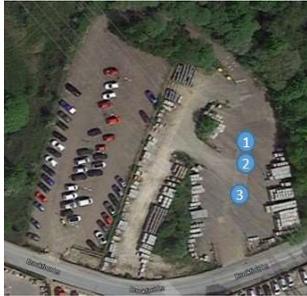
Brookfoot – 19 yrs old

### 1. Brookfoot Works Car Park, Halifax, HX3 9SY. Installed 2001.

A test panel (approx. 5mx10m) installed in the exit lane of a car park servicing a concrete works. The car park is heavily used by 3 daily shifts of factory staff 7 days a week (up to 100 cars daily) and is also subject to heavy plant moving pallets of concrete products and aggregates. No maintenance has been undertaken whatsoever.

The surface is well worn. Most joints have sand and debris in them and some moss is visible. Some joints appear completely clogged with compacted sand.

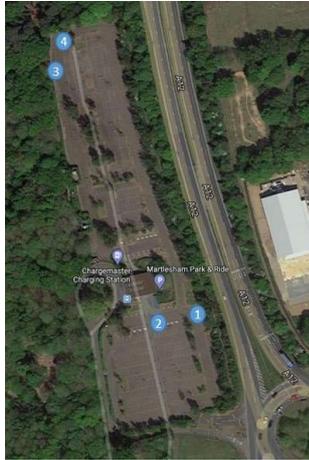
Martlesham – 17 yrs old

### 3. Martlesham Park & Ride, Ipswich, IP5 3QN. Installed 2003.

A large out-of-town car park which receives regular daily trafficking from commuters and shoppers. Occasional sweeping is undertaken around the edge of the space to tidy up foliage from overhanging vegetation, but otherwise no specific maintenance has taken place.

There is heavy moss in most joints. Towards the edge of the site there are large amounts of loose debris from trees and shrubs. The original designer of the scheme from Suffolk County Council was present at the test.

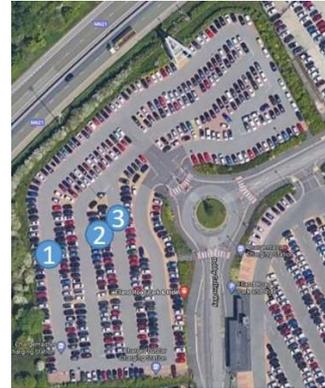
Elland Road – 6 yrs old

### 2. Elland Road Park and Ride, Leeds, LS11 0EY. Installed 2014.

A large out-of-town car park next to the football stadium. Two new phases have been added since this first one, both using CBPP. The car park receives regular daily trafficking from domestic cars. The car park is swept annually and during winter salt is applied (without added grit or sand) as a de-icer.

There is moss and debris visible in most joints in the parking bays, but joints the running lanes seem to be more open. Mossed joints are particularly evident in bays round the edge of the car park. Jointing aggregate is no longer present. Representatives from Leeds County Council were present at the test.
